Pilot Study to Characterize Ordnance Contamination Within the Sea Bright, New Jersey, Sand Borrow Site

by Joan Pope, Richard Lewis, Andrew Morang, Timothy Welp

Final report

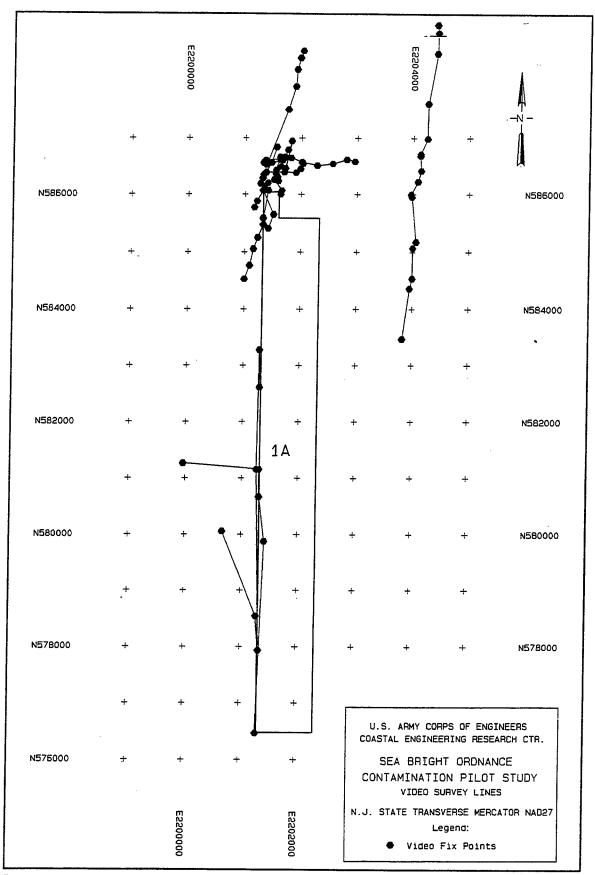
Figure 4. Underwater video survey lines. Borrow area 1A shown for reference

Ideally, remotely operated underwater cameras are controlled from a motionless vessel. However, the project safety plan prohibited anchoring of manned vessels, and strong tidal currents and wave action at this site caused significant vessel drift. Thus, both the ROV and the low-light camera were towed over the bottom in the same areas but independent of the other instruments. Areas viewed during the video tows are shown in Figure 4.

Video image observations revealed the bottom borrow areas to be sandy with some rhythmic topography (sand ripples) and occasional coarser sand/gravel streaks (usually in the troughs between the sand waves/ripples). Several pieces of suspected ordnance were observed. The video tows included several drifts to the north of borrow area 1A. Here, the camera passed over a bottom which changed from clean sand to hummocky-clay zones. The clay was scarred with current marks. Bottom debris (plastic, ceramics, metal, and suspected ordnance) were observed in these clay zones.

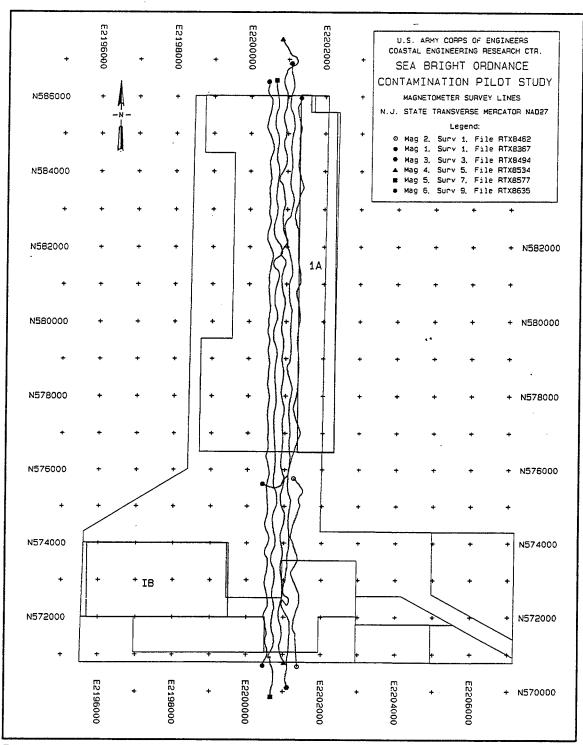
Figure 7. Long magnetometer survey lines. Overall Sea Bright borrow area shown for reference

borrow area. Magnetic signatures obtained during the pilot study indicated the presence of numerous dipole objects corresponding to ordnance signatures in the areas surveyed. The occurrence of these characteristic signatures diminished toward the south. The most common detected dipole objects were:

(a) comparable in size to 6- to 12-in. shells, (b) located at or near the sand surface, and (c) oriented generally parallel to the shoreline (north-south). This information has implications concerning the mobility of the ordnance and methods to be used in any potential site cleanup operations. Other specific magnetic signatures have been identified as representing metal spheres (such as a cannon-ball), marine clutter (such as a zone of odd-shaped metal fragments), and larger objects (drums and possibly shipboard jetsum). Further post-processing of the magnetic data would give additional information concerning individual objects and the orientation, approximate size, and three-dimensional location of these defined targets.

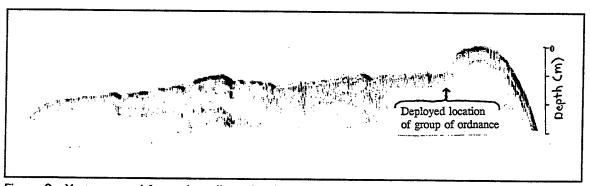
Figure 9. X-star record from along line of ordnance placed for test of system

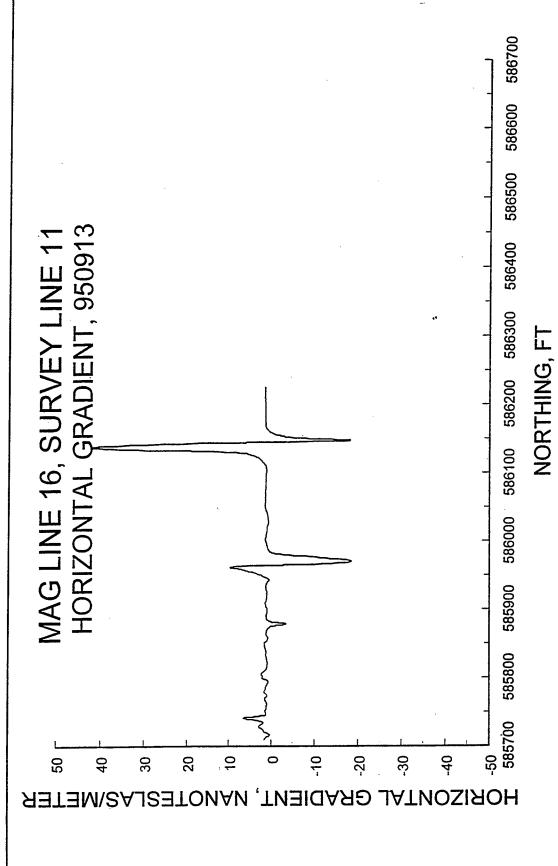
Figure 13. Horizontal magnetic gradient recorded in ordnance disposal area, magnetic line 16 (reference Figure 6)

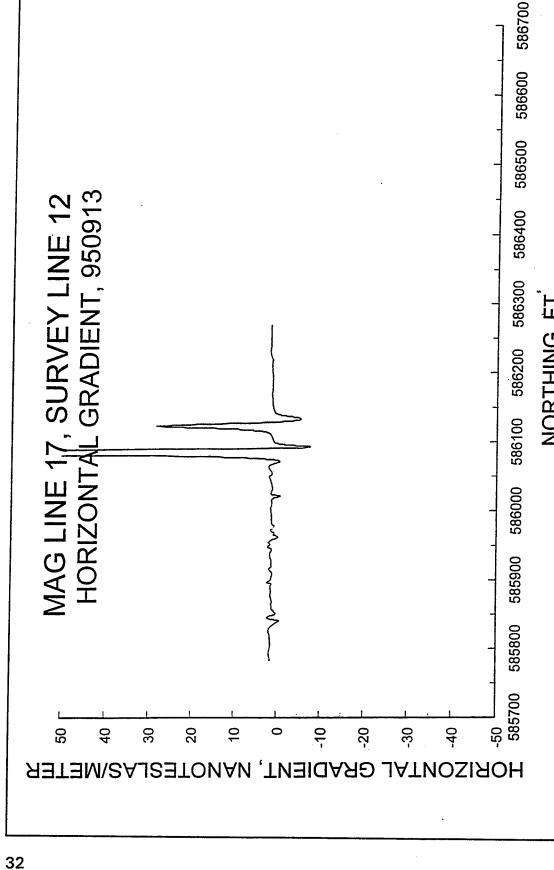
Figure 14. Horizontal magnetic gradient recorded in ordnance disposal area, magnetic line 17

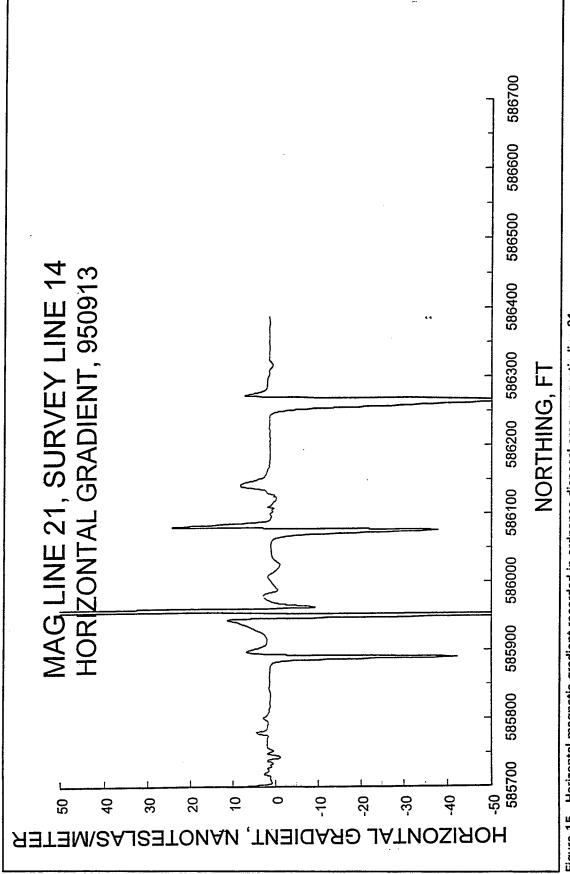
Figure 15. Horizontal magnetic gradient recorded in ordnance disposal area, magnetic line 21

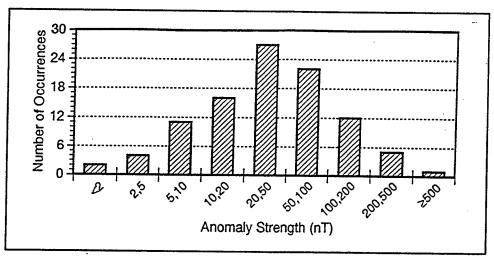
Figure 28. Anomaly strength (peak signal magnitude) of 100 samples selected from the north-south magnetometer lines. (Plot provided by AETC)

One hundred magnetic anomalies were selected from the survey data for detailed analysis to demonstrate the target characterization procedures. The data were taken from the six long north-south lines. A histogram of the distribution of anomaly strengths is shown in Figure 28. With few exceptions, the apparent dipoles were oriented more or less to the north, suggesting that ordnance in this area is lying on the seafloor approximately parallel to the New Jersey shore. Distribution of the estimated cross-track locations of the 100 anomalies is shown in Figure 29. Positive values are to the right of the survey track line, and the shaded area shows the detection swath width for the magnetometer array used during this survey. With the magnetic sensor array flying at about 1.7 m above the seafloor, the system detected objects at a range slightly over 4 m to either side. Sensitivity studies based on dipole anomalies embedded in uncorrelated Gaussian noise demonstrated that for these ranges, typical ordnance can be located with 10- to 20-cm accuracy using the survey data.

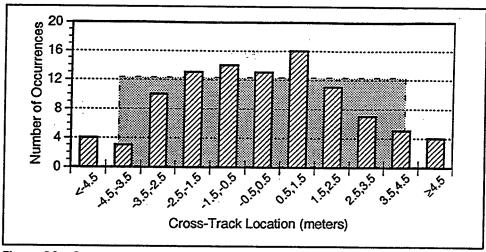
Figure 29. Cross-track locations, 100 analyzed samples. Shaded area indicates computed detection range of array used in the field. (Plot provided by AETC)

A total of 240 anomalies were counted by AETC during their analyses. Assuming that all the anomalies correspond to targets and that the detection swath is 4 m to either side of the track, this amounts to an ordnance density of about 15.4 objects per hectare. The raking operation recovered ordnance at only one tenth of this density, about 1.3 objects per hectare. The discrepancy may be due to three factors. First, not all anomalies may be caused by actual ordnance but rather by other sorts of metallic debris. This, however, is not likely to be significant due to the average precision of fit which exceeded 0.98 of the measured magnetic anomalies to simple dipole models. Most marine debris would not be representative of simple dipole magnetic sources. Second, the raking operation may have failed to recover many ordnance items on the seafloor. Preliminary tests in other locations have shown that many shells fall out of the rakes before they can be retrieved onto the deck of the vessel. Also, a factor due to the raking activity occurred in Borrow area 1A, which is seaward of the area evaluated by AETC. Most likely the difference is from the shallow depth (10 cm) that the Miss Kathy was able to reach. Analysis of the depth of the ordnance, Figure 29, shows that most of the ordnance is below 10 cm in the sand, but buried shallower than 1.5 m.

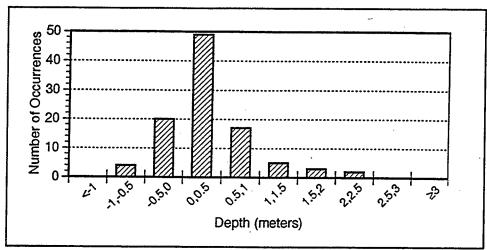
Figure 30. Computed depth from seafloor to center of objects. Negative values correspond to dipole fits where the center of object is above the bottom. Most objects are lying on the seafloor. (Plot provided by AETC)

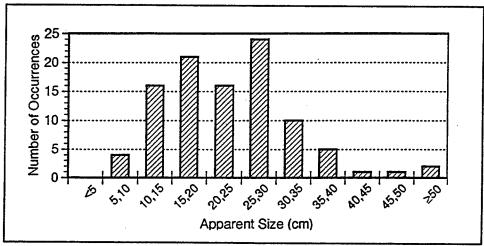
Finally, Figure 31 shows the distribution of apparent sizes of the anomalies. The apparent size of an object is its equivalent radius, which is the radius of a steel ball having the same dipole moment. Bell, DeProspo, and Prouty (1996) found that ordnance caliber is almost equal to the measured dipole radius. Figure 31 also shows that objects range from 5 to 50 cm, with the most common clustering between 10 and 35 cm (4 to 14 in.). These sizes are consistent with the caliber of ordnance recovered in the test raking operation by the *Miss Kathy*, but the distribution is different. The distribution of the raked ordnance was dominated by smaller pieces (*i.e.*, 8- to 13-cm range), and the raking operation only recovered 24 objects, a sample size too small to use to evaluate the distribution of size classes (Figure 32).

Figure 31. Distribution of apparent sizes of the 100 test objects. (Plot provided by AETC)

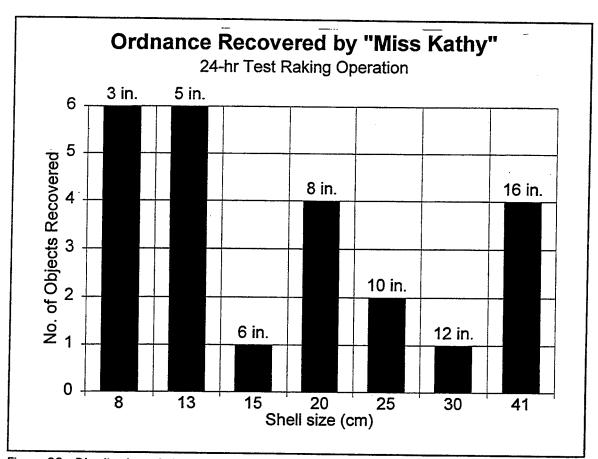
Figure 32. Distribution of sizes of ordnance recovered during 24-hr test raking operation
